The Pavilions at the Alhambra's Court of the Lions: Graphic Analysis of Muqarnas

Abstract: This research documents and graphically analyzes the pavilions muqarnas at the Court of the Lions in the Alhambra in Granada, a World Heritage Site. In order to cast some light on the understanding and preservation of these 14th century architectural elements, after a brief report of historical data on catastrophes and restorations, a novel methodology for the case study based on three complementary graphic analyses is presented here: First, there is a review of outstanding images ranging from the 17th to the 20th centuries; subsequently, new CAD (computer-aided design) drawings from pavilions muqarnas testing the theoretic principles from their geometric grouping are accomplished for the first time; and finally, a 3D laser scanner is used to understand the precise present-day state from the point cloud obtained. Comparing drawings allows us to assess the muqarnas relevance while proving, for the first time, that the muqarnas of both pavilions have distinct configurations and different amounts of pieces. Besides, this process reveals geometric deformations existing in the original Nasrid muq

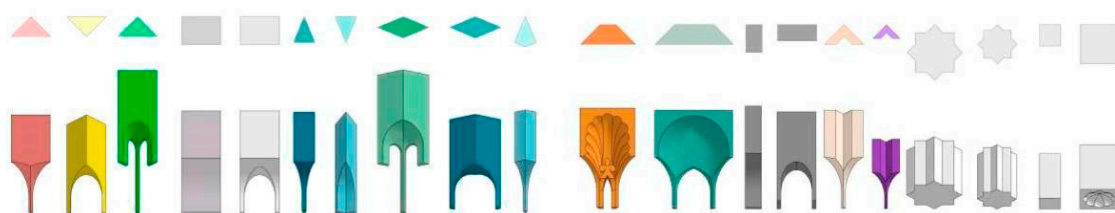
Figure 9. Pieces library from the pavilions at the Court of the Lions [authors' own drawing].

From the aforementioned precedents and a careful observation of reality, this research identified the existing pieces in both pavilions to consequently draw their plans and basic volumes. Different colors have been assigned to each type of piece to facilitate its location in the subsequent drawings of groupings (Figure 9).
